Manhole Inspection Summary

Manhole # S33E__025MH

Insp Date: 11/11/08 12:23 PM

Location Address: **100 w fayette st**

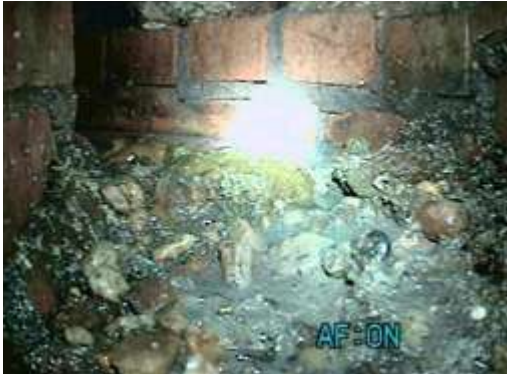
Defect 5

Condition: ☐ Sound ☐ Cracked ☐ Root Intrusion ☐ Deteriorated ☐ Leaks ☒ **Debris**

channel debris

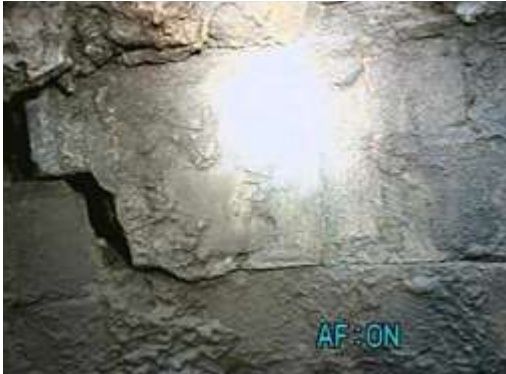
Defect 4

Condition: ☐ Sound ☒ **Cracked** ☐ Root Intrusion ☐ Loose Brick ☐ Deteriorated

crack corbel

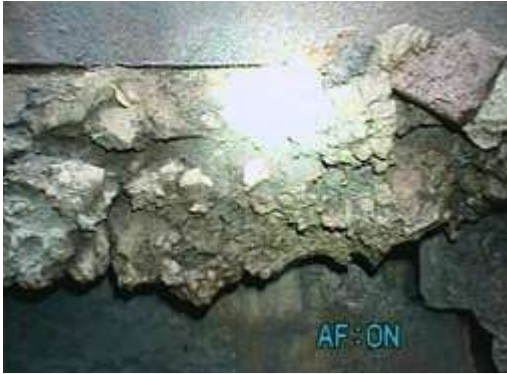
Defect 3

Condition: ☐ Sound ☒ **Cracked** ☐ Root Intrusion ☐ Loose Brick ☒ **Deteriorated**

cracked and deteriorated chimney, frame adj

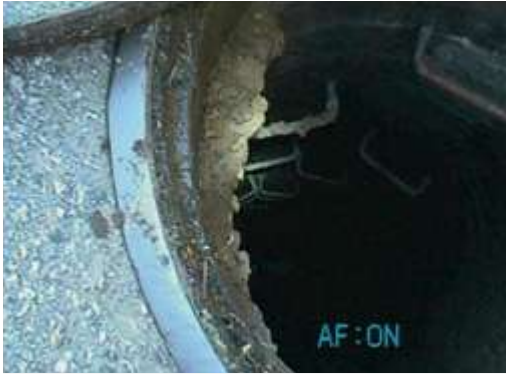
Defect 2

Frame Offset: **2** (in.) Condition: ☒ Sound ☐ Cracked ☐ Leaks

offset

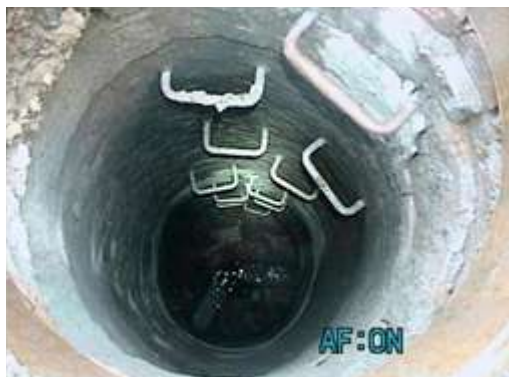
Defect 1

Steps Count: **11** Missing: **0** ☒ **Corroded**

cor. steps

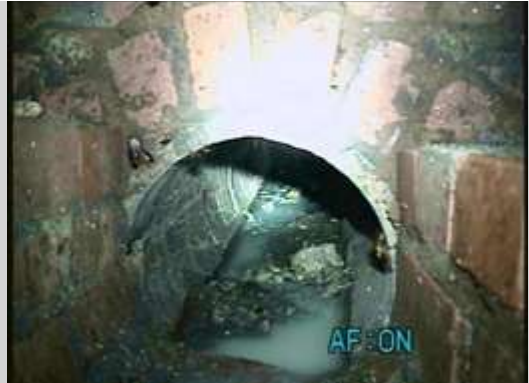
12 O'Clock Outflow

10 in. Circular Gravity Sewer
Pipe Out @ 12 O'Clock

Pipe Material: **Clay** ☐ Pipe Lined

Invert Depth: 17.41 (ft.) Flow Characteristics: **None**

Infiltration: **None** Pipe Seal Cond: **Unknown**

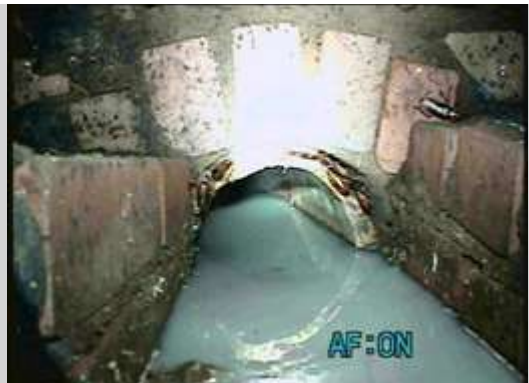
4 O'Clock Inflow

10 in. Circular Gravity Sewer
Pipe In @ 4 O'Clock

Pipe Material: **Clay** ☐ Pipe Lined

Invert Depth: 17.16 (ft.) Flow Characteristics: **None**

Infiltration: **None** Pipe Seal Cond: **Unknown**
